GOUGH 86

NEW BRIDGE

COPY OF "PHOTO" REPORT.

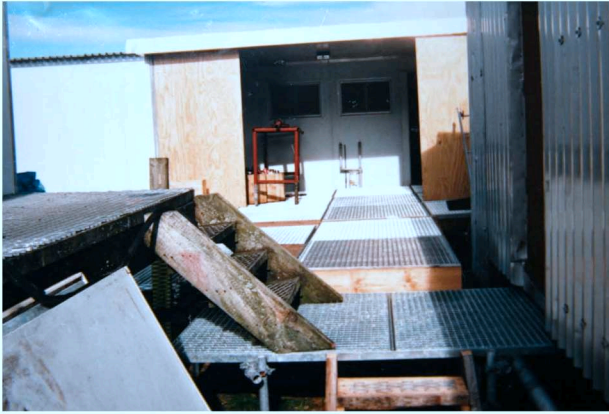
NEW TIN CRUSHER ENCLOSURE:
IT IS RECOMMENDED THAT THE
FRONT BLOCKBOARD PANELS
BE REPLACED WITH "LINDE
PANELS OR ALUMINIUM
SHEETING.

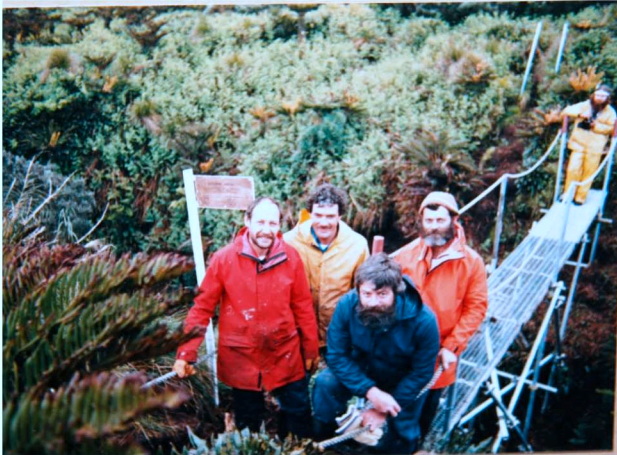
NEW BRIDGE JUST COMPLETED.
NARROW GAUGE STEEL CATWALKS
WILL BE AN IMPROVEMENT.

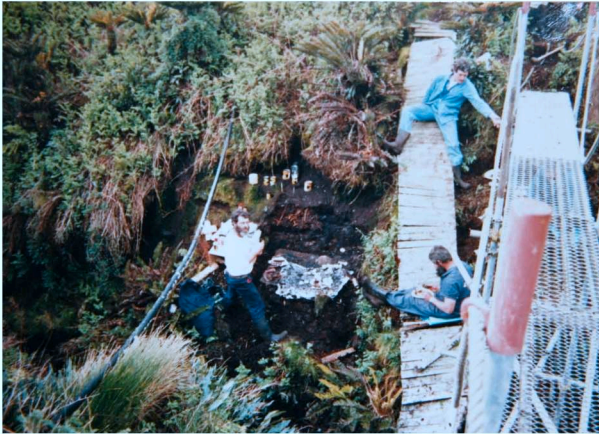
CONDITION OF OLD
BRIDGE

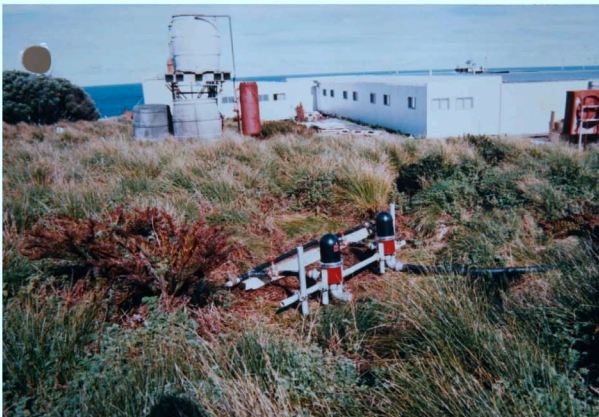
NEW FILTERS INSTALLED
TO IMPROVE WATER
PRESSURE ON HOT
WATER CYLINDERS.

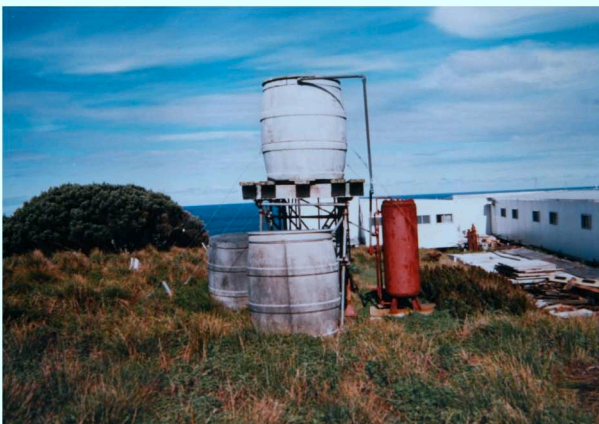
THE FIVE RESERVE
WATER TANKS WHICH
NEED A NEW STAND,
TANKS SHOULD ALSO
BE REPLACED.

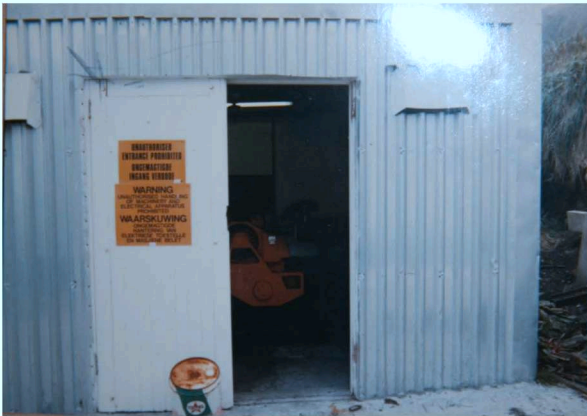
CRANE POWER SHACK:
FRONT DOOR WAS BLOWN
OFF AND A NEW STEEL
DOOR IS RECOMMENDED
FOR 1987. TEMPORARY
REPAIR WAS EFFECTED
BUT FRAME IS DAMAGED.

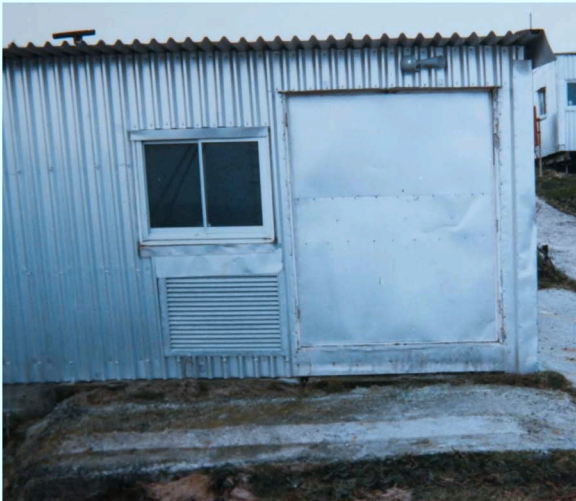
CRANE POWER SHACK:
SIDE DOORS WERE
COMPLETELY BLOWN OFF
AND HAS SINCE BEEN
REPLACED WITH A PURPOSE
MADE GALV. STEEL UNIT.

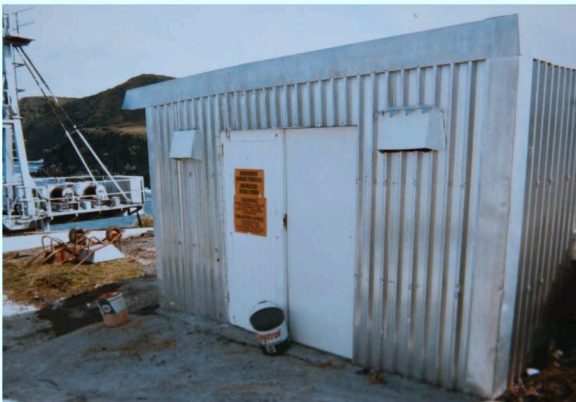
LANDING STAGE HAS BEEN
ENLARGED FROM CRANE
EDGE TILL POWER SHACK.
SERVICE WAS STILL INCOMPLETE
AT TIME OF "PHOTO"
