# DEPARTMENT OF PUBLIC WORKS

## MARION ISLAND

### METEOROLOGICAL STATION

MAY 1997 EXPEDITION

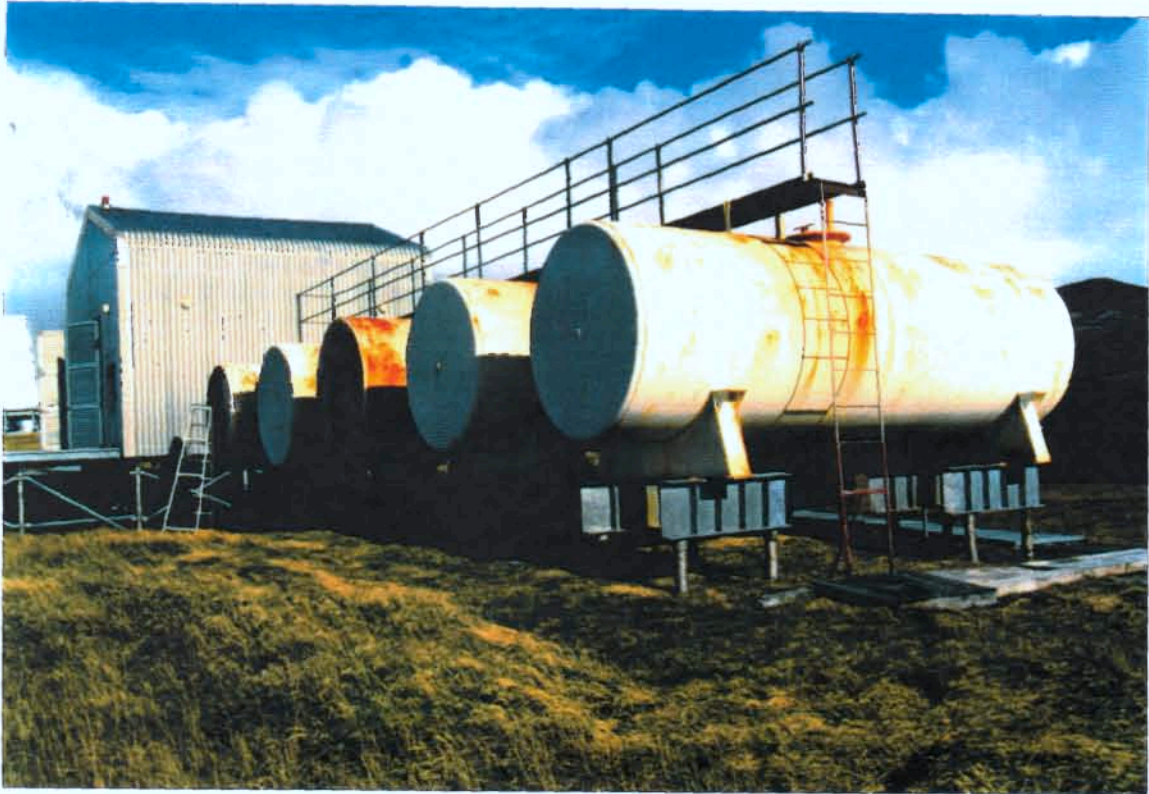
**Bulk storage diesel tanks:**  
Original condition of tanks before refurbishing.

The five Diesel tanks, numbers from 14 to 18 at the ADE power shack were needle gunned and painted to specification. These tanks still require to be **internally cleaned**, it is recommended that this service be carried out during the next expedition. All valves, fuel lines were checked for leaks, and the defective valves were replaced with new.

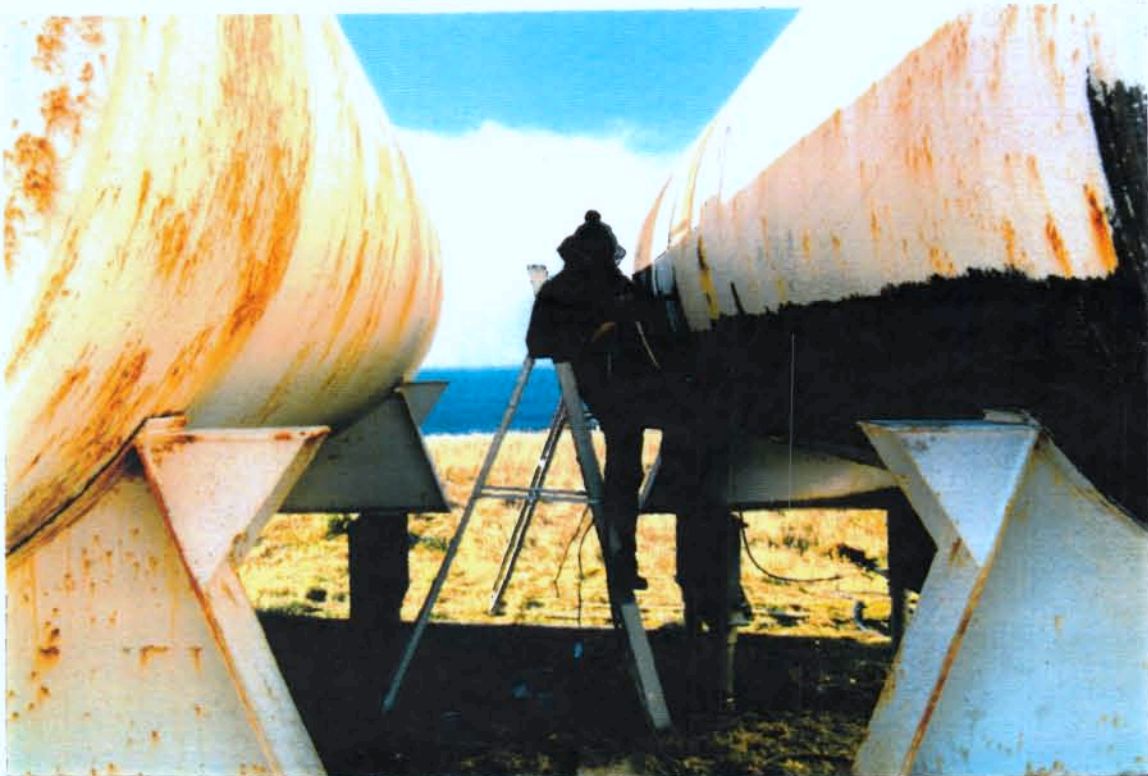
**Bulk storage diesel tanks:**  
Removing of old paint and rust by means of needle gun.

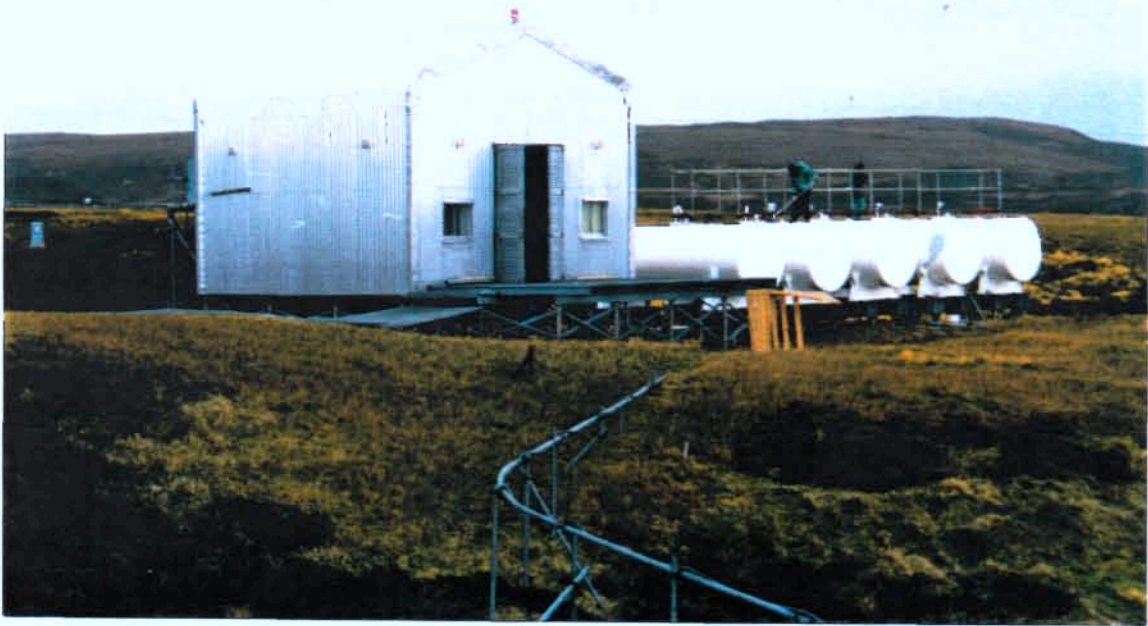
**Bulk storage diesel tanks:**  
Condition of tanks after refurbishing.

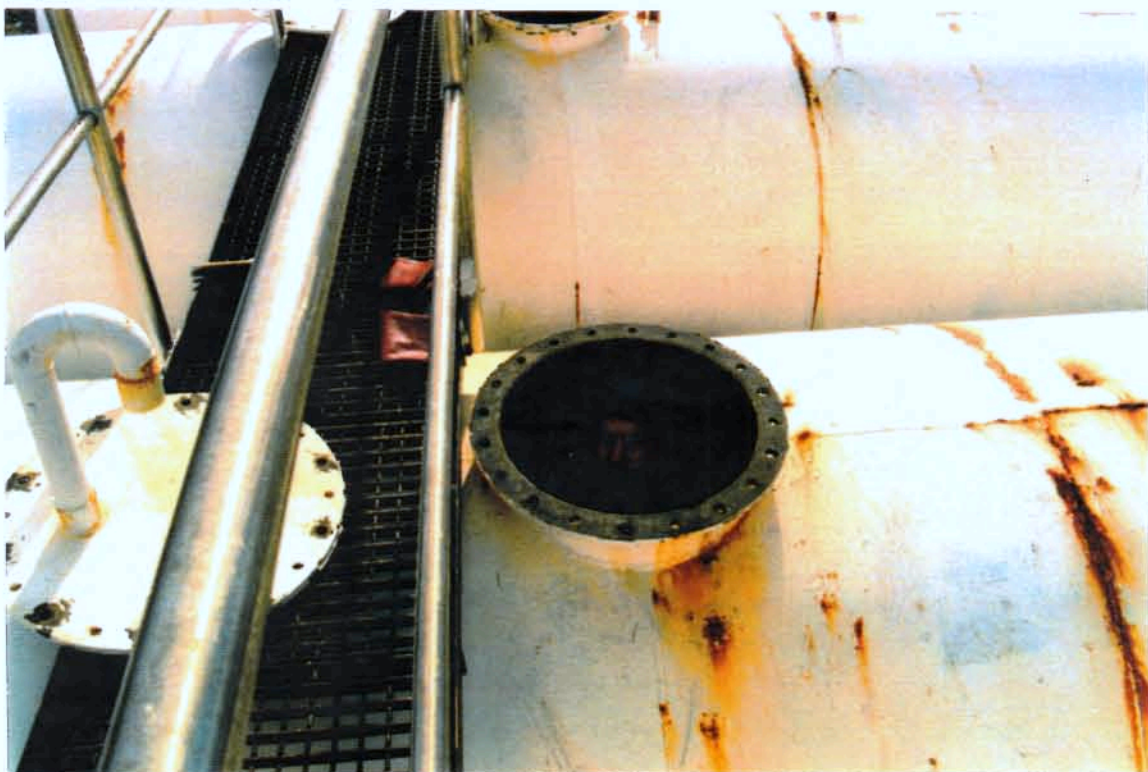
**Bulk storage diesel tanks:**  
Internal cleaning of tanks

Storage tank numbers from 1 to 9 which is situated in the front of the Kitchen area were internally cleaned. The paint on these tanks is still in a reasonable condition, however it is recommended that they be repainted during the next expedition.

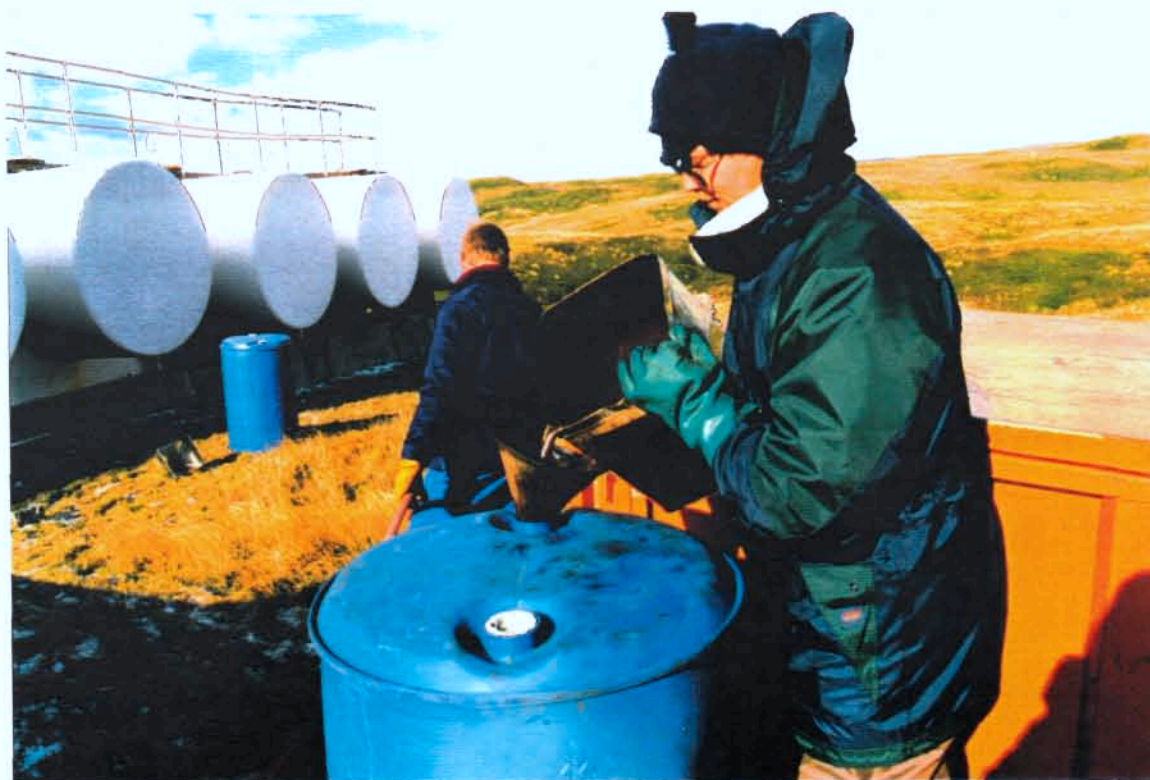
**Bulk storage diesel tanks:**

Dirty diesel sludge been poured into 200 L plastic drums for return to Cape Town.

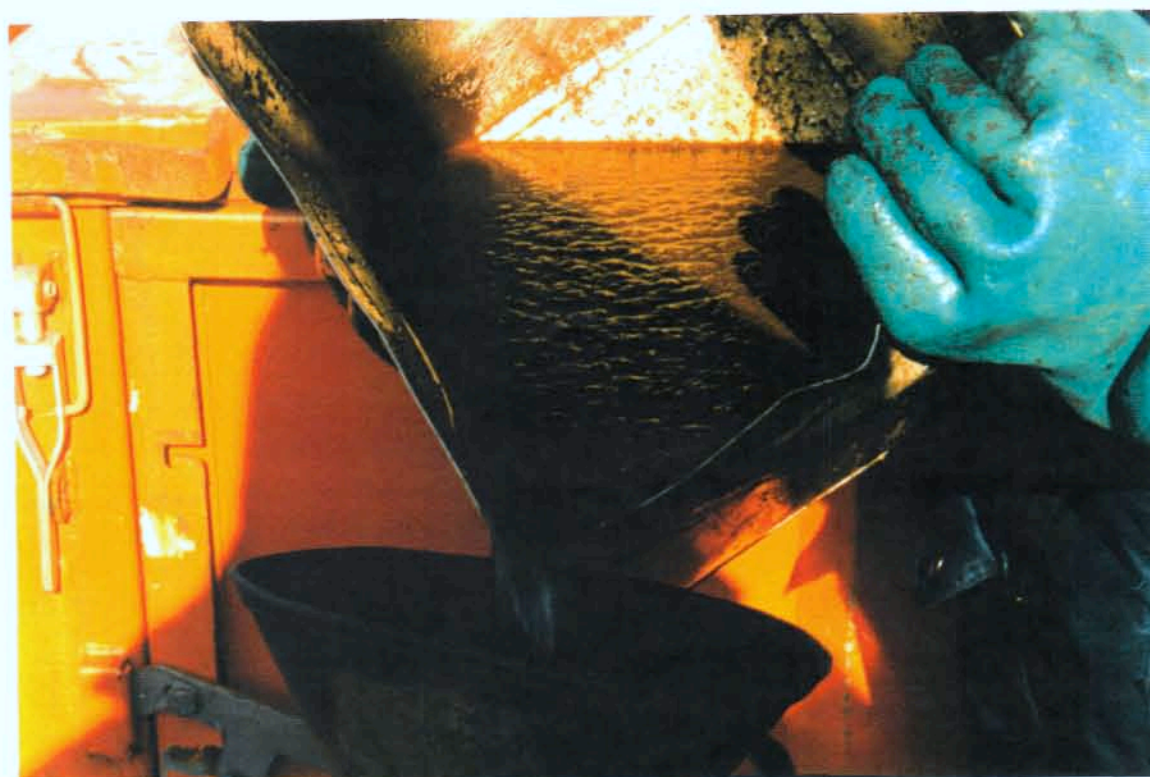
**Bulk storage diesel tanks:**

Condition of diesel sludge.

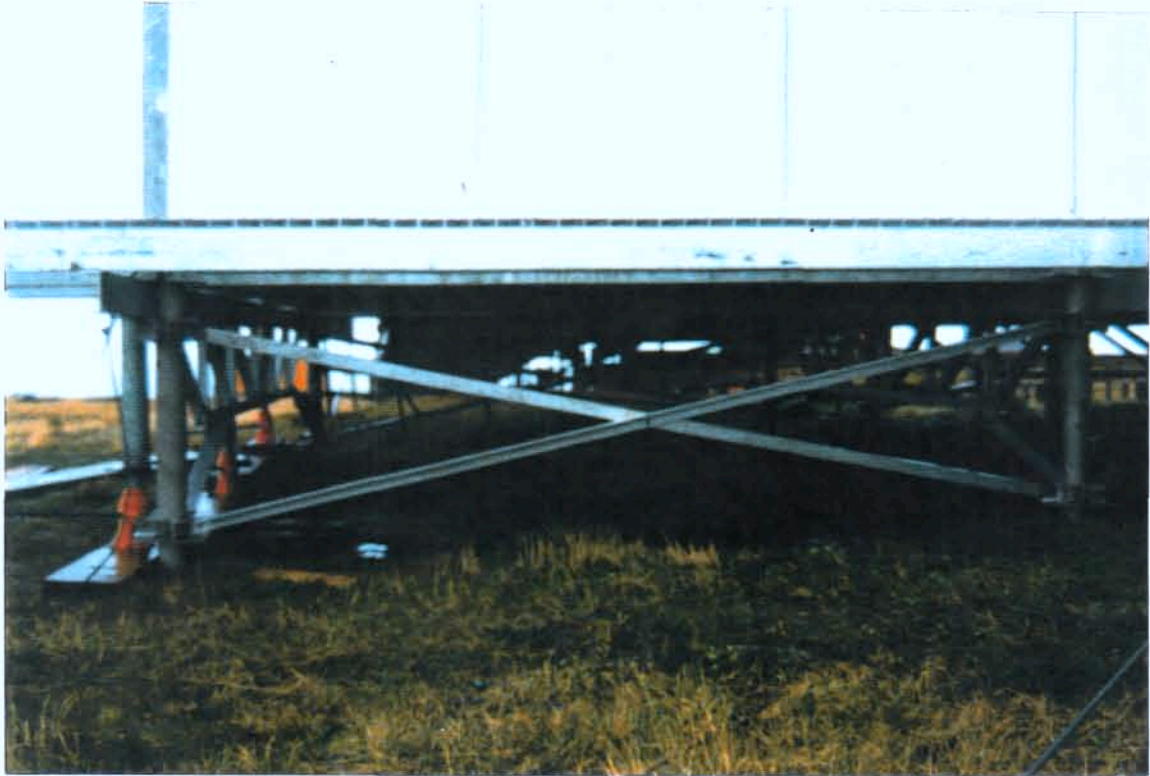
**Upper Air Building:**  
Aluminium bracing in position after installation.

Additional supports were also fitted under the floor of the hydrogen generator, so as prevent further movement. All wall and floor panels were resealed with silicon sealer where it parted due to above problem. The sections of the wall panels that were treated with the Leo stainless steel paint. (*See photograph.*)

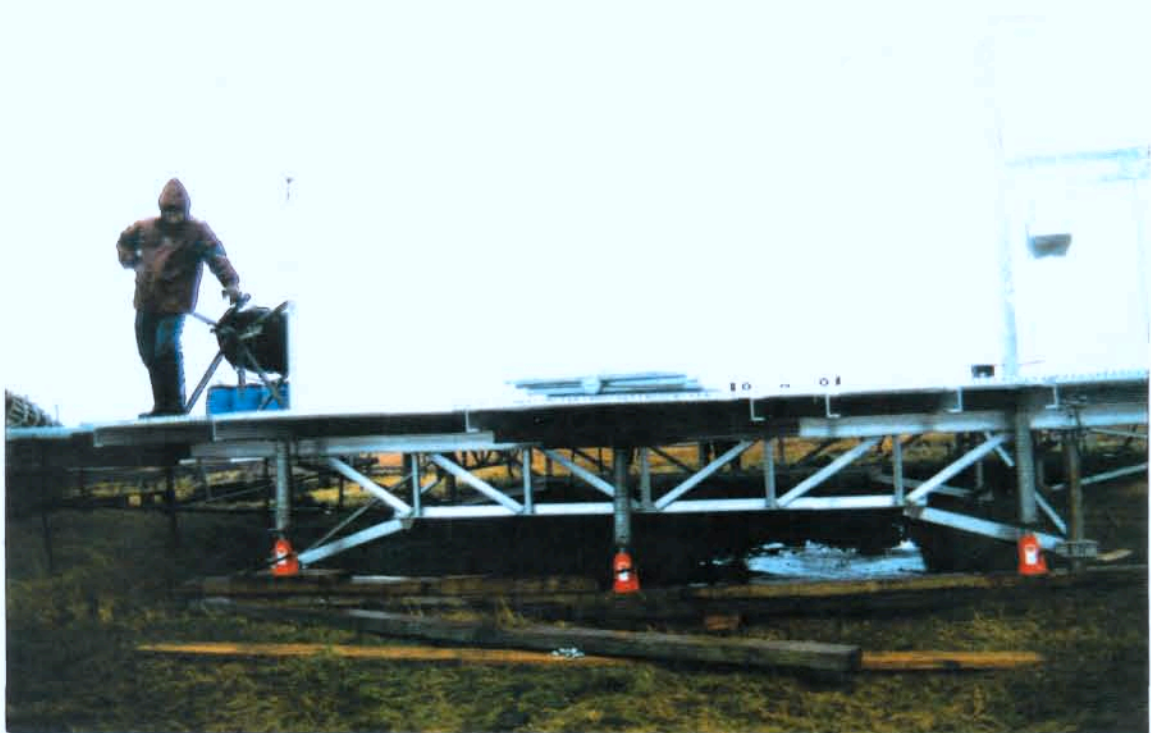
**Upper Air Building:**  
Building been raised and straightened with the aid 20 ton bottle jacks.

The problem with the doors not closing properly was also solved once the building was straightened, however the two cold room type door locks on the entrance doors were defective. Temporarily repairs were carried out on the door locks by stripping them and re-assembling them as there were no spare locks available. At present the doors are functioning, but these locks would require replacement during the next take-over.

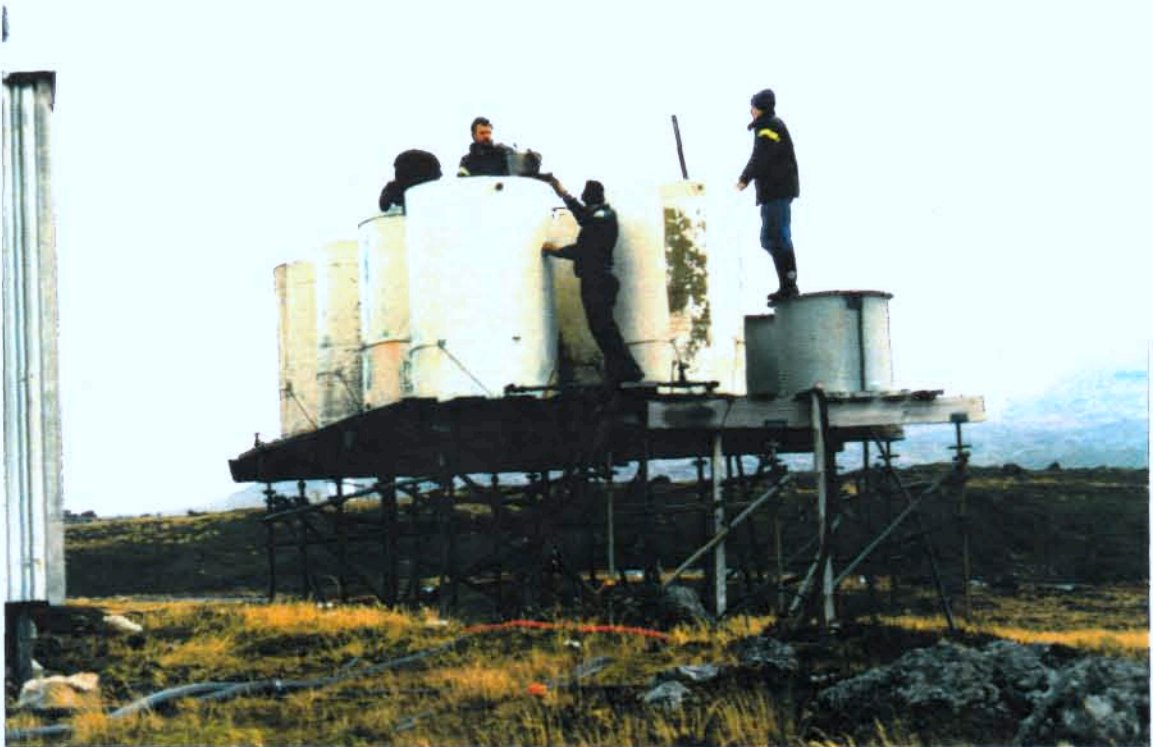
**Fresh water storage tanks:**

PWD team busy with the internal cleaning of the water tanks.

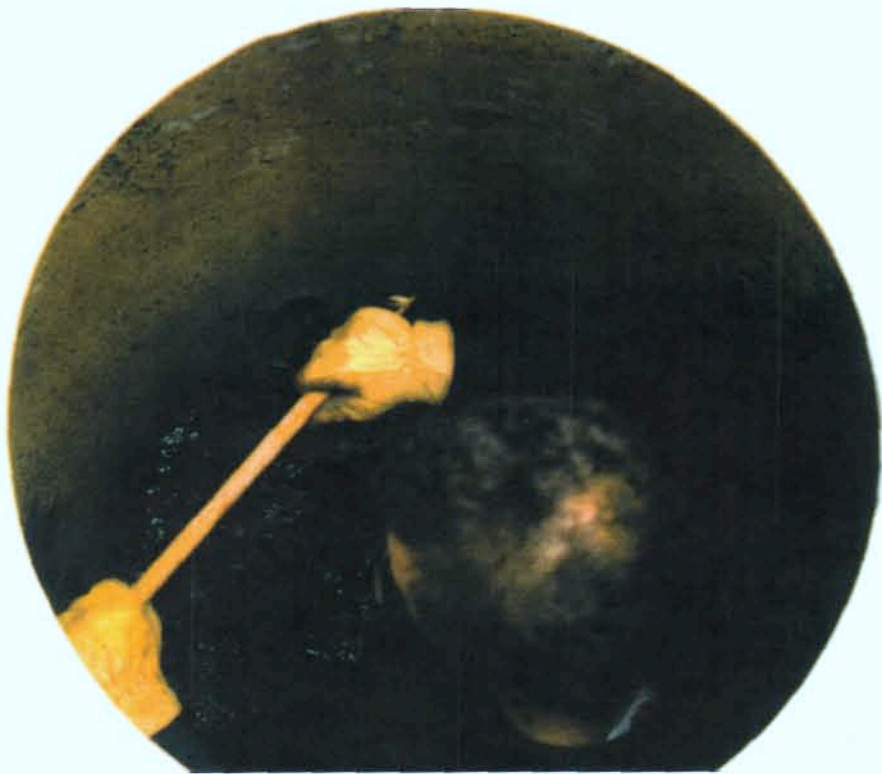
**Fresh water storage tanks:**

Algae build up been removed in water tanks.

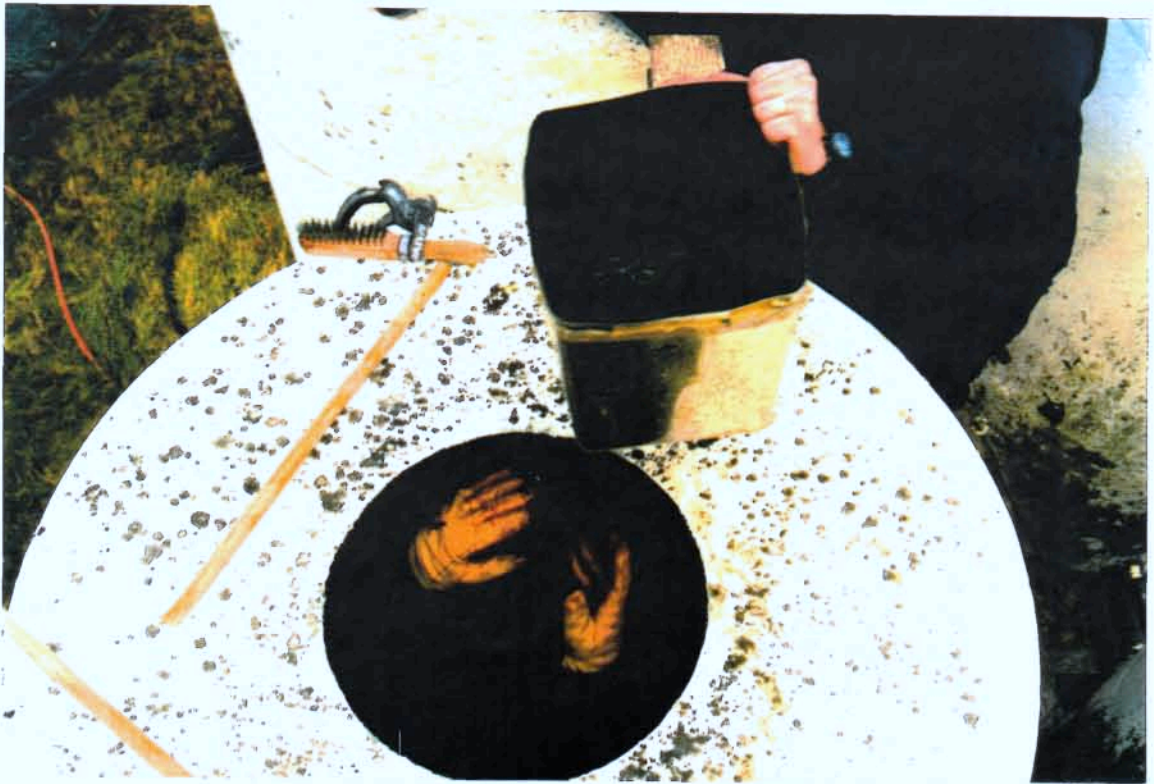
**Fresh water storage tanks:**  
Condition of dirty water.

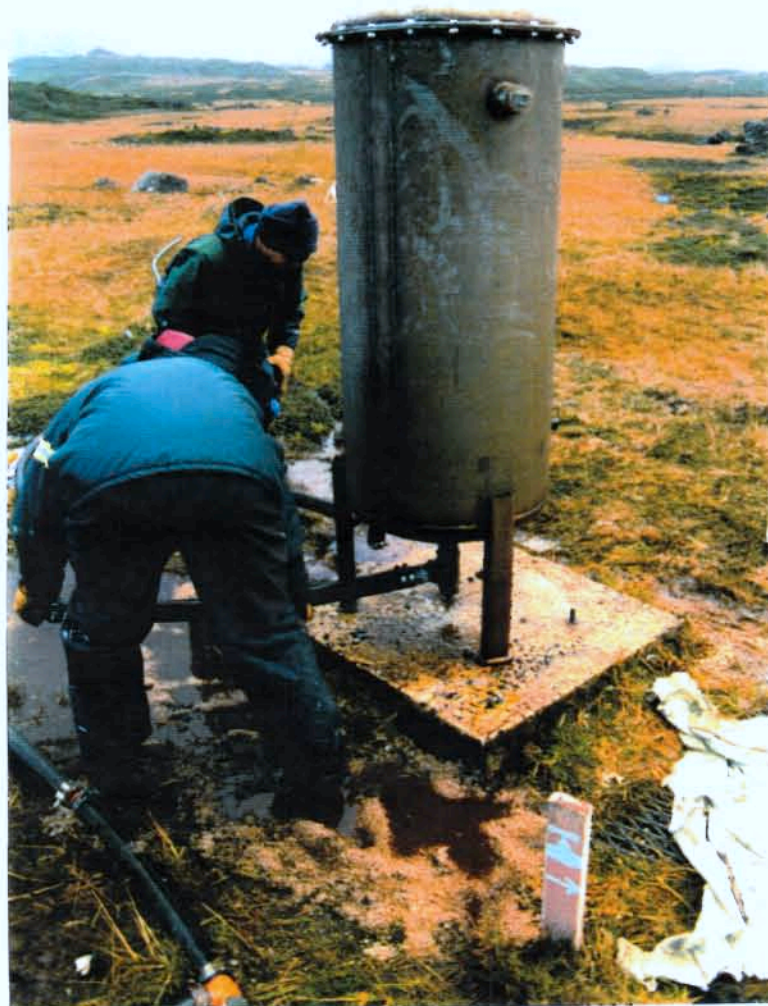
**Sand filter:**  
Repairs been carried out on filter.

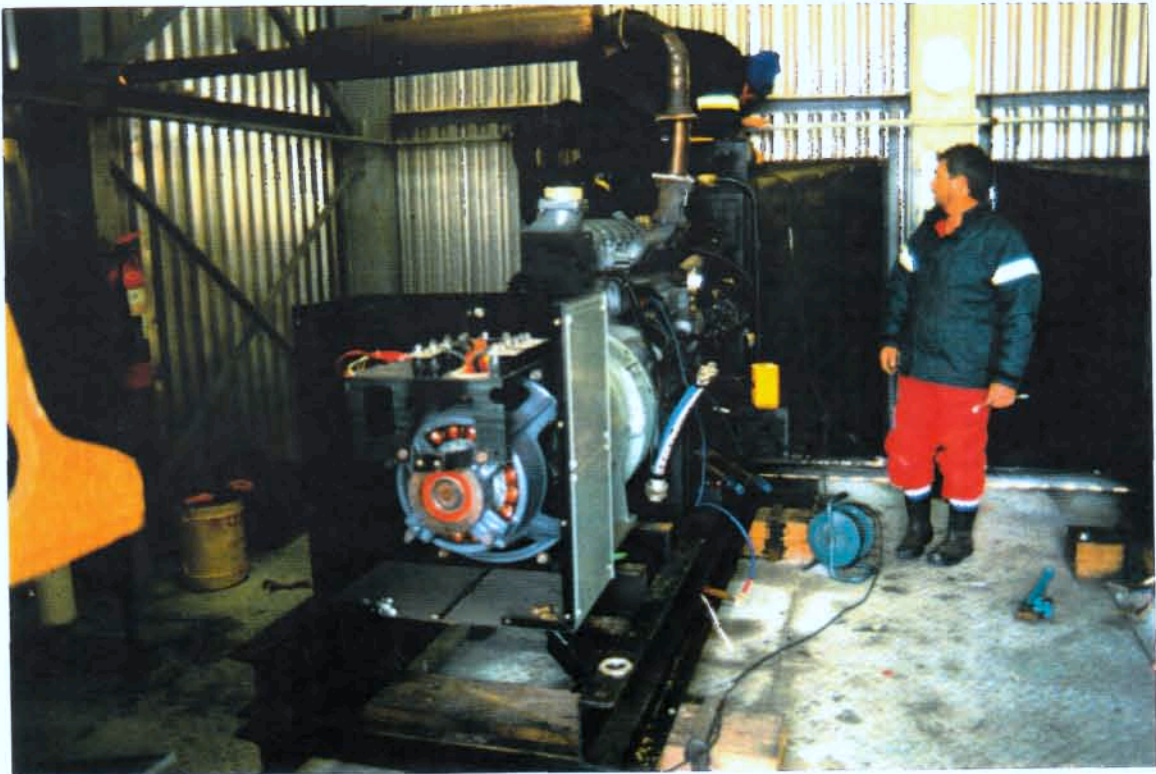
**ADE Power House:**  
Installation of ADE generator no. 1.

The ADE motor generator No.1 which was overhauled back in Cape Town was reinstalled, various faults on the controls were repaired and the governor set to specification.

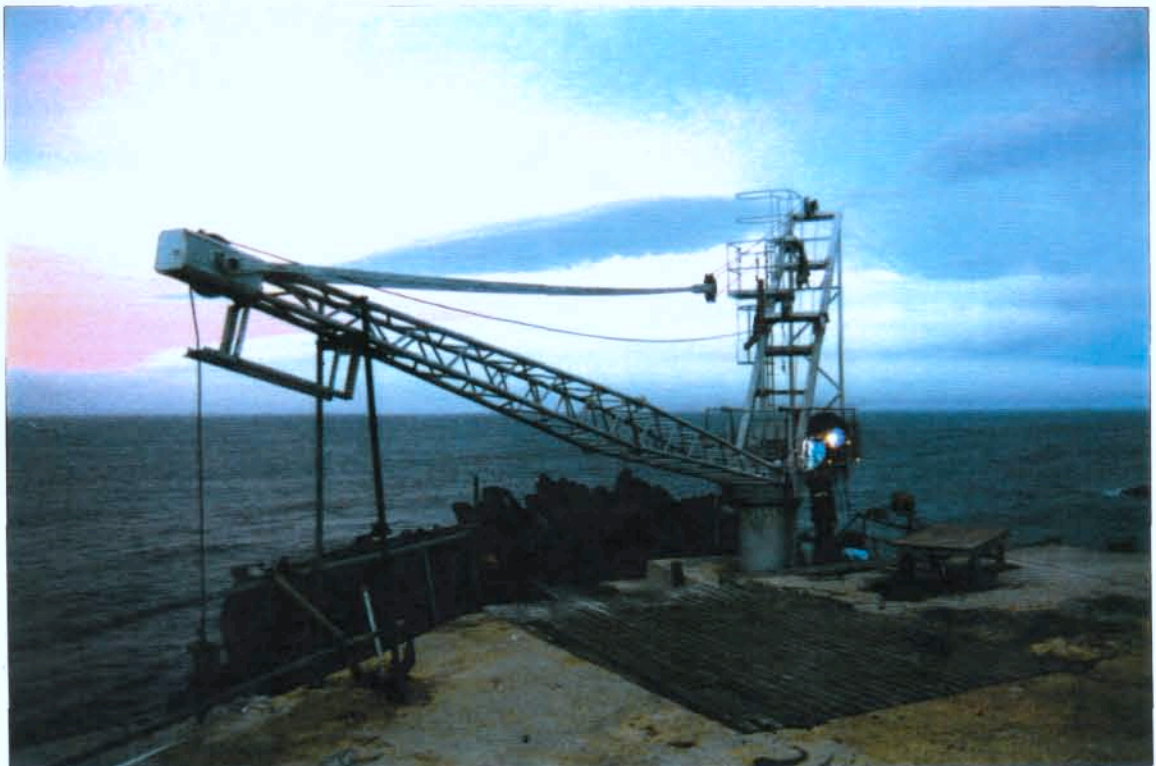
**Crane:**  
Repairs been carried out on crane.

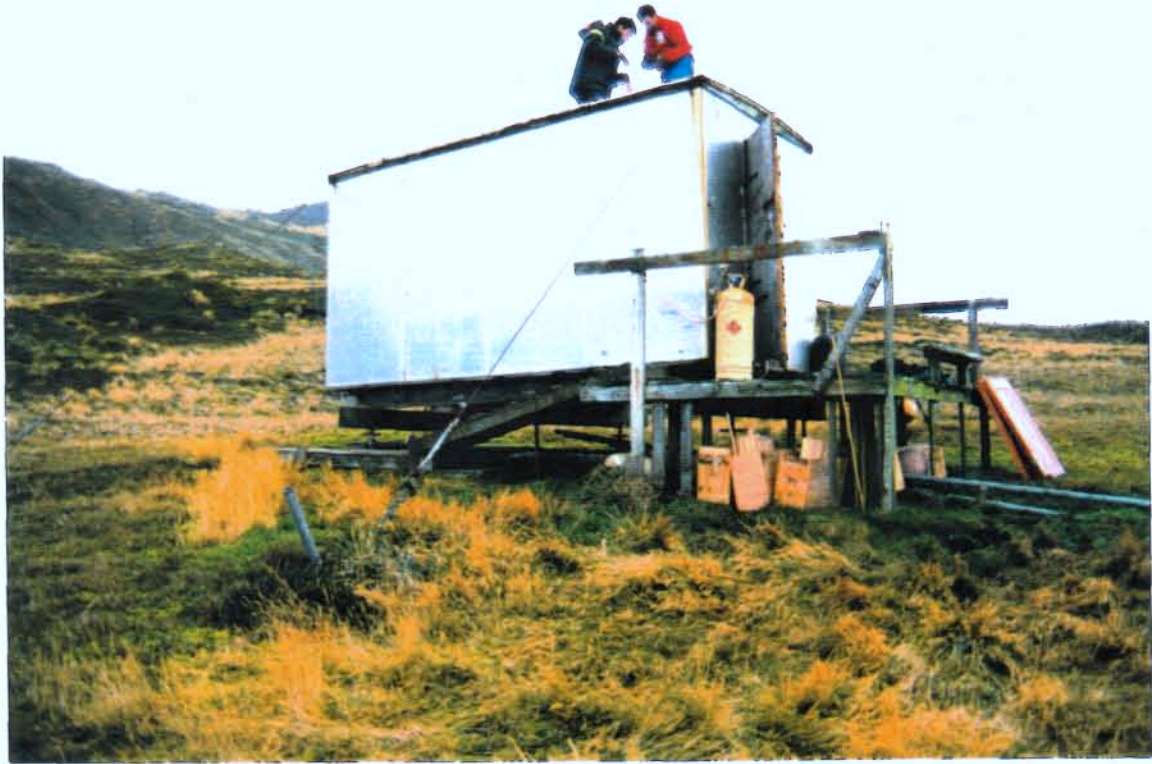
**Mixed Pickle Hut:**  
PWD artisans busy replacing roof sheet.

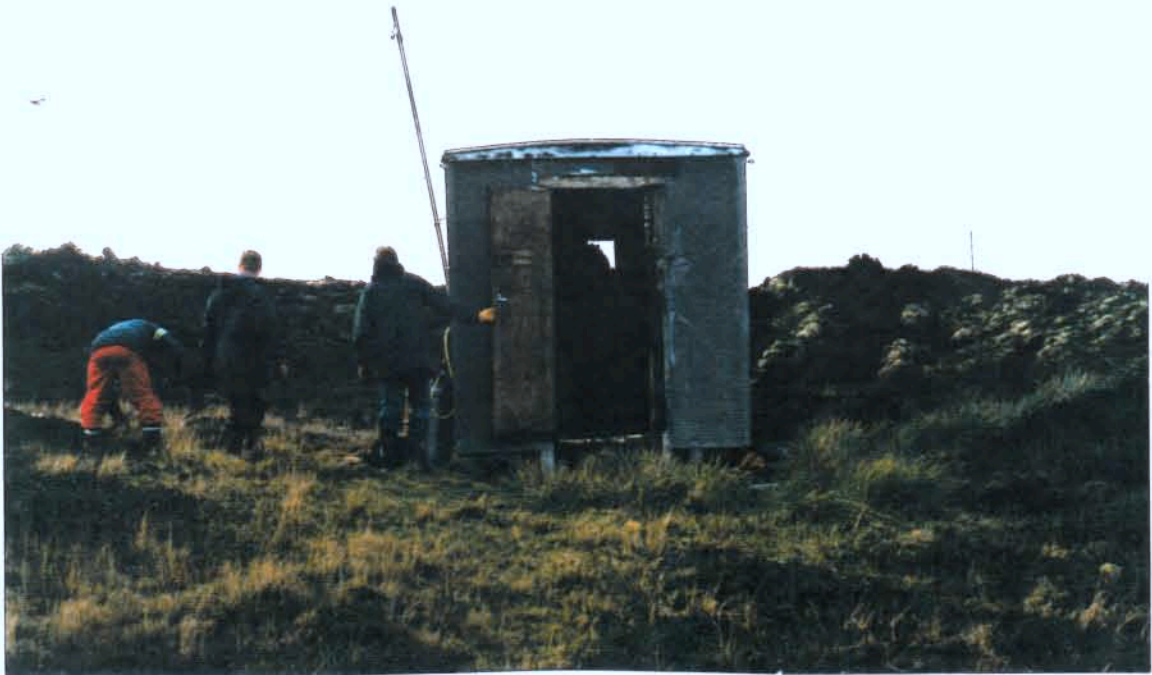
**Grey Headed Hut:**  
PWD artisans busy with repairs.

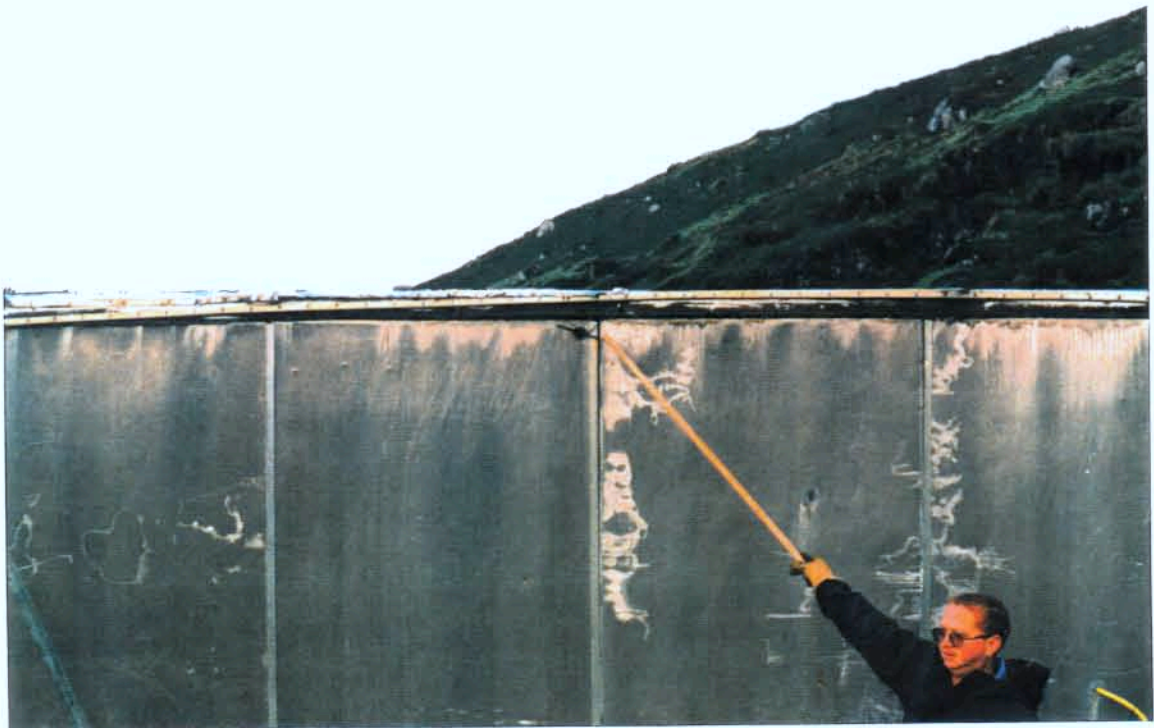
**Grey Headed Hut:**  
Position where panel had crack.
