GOUGH 1994 EXPEDITION

GOUGH ISLAND

1994 EXPEDITION

BUILDING REPORT

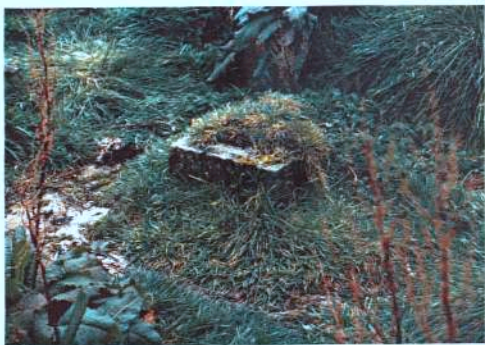
The concrete slab is in the process of being covered by indigenous vegetation and the conservation officer has stated verbally that the area should be left as is, so as not to do any further damage to the area.

THE CONCRETE SLAB FROM THE OLD HUT IS IN THE PROCESS OF BEING COVERED BY INDIGENOUS VEGETATION AND SHOULD NOT BE REMOVED

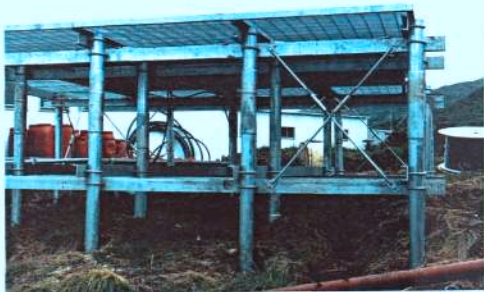
The foundation pipes were driven to a depth ranging between 9m and 12m into the ground. The whole installation fitted together without any major problems arising. No difficulty was encountered with the erection of the building and the whole project ran very smoothly.

VIEW OF THE PIPE FOUNDATION AND THE COMPLETED SATELLITE BUILDING
WHICH IS SITUATED NEXT TO THE BALLOON HUT.

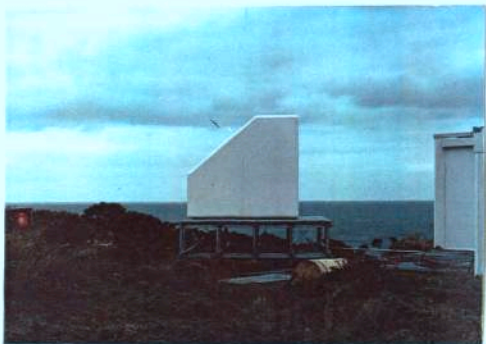
This building was demolished as there was no further use for it. This has now created a much larger loading area for material and stores which come ashore.

VIEV OF THE LANDING STAGE WITH THE OLD EMERGENCY POWER SHACK REMOVED. THIS HAS ALLOWED MORE SPACE FOR HELICOPTER MOVEMENT.

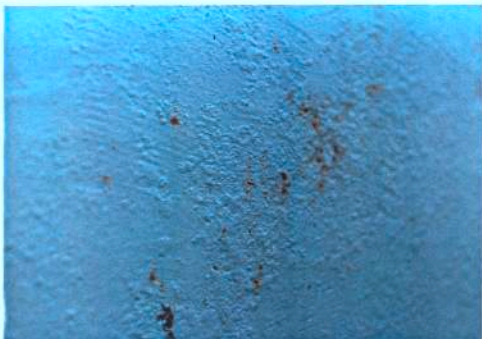
The tanks are structurally in a good condition. The shells of the four (4) furthestmost tanks tend to be pitted more than the others, but this is probably due to the sea spray which reaches them when rough seas are experienced.

VIEW OF PITTING WHICH IS TAKING PLACE ON THE SHELL OF THE FOUR (4)
FURTHERMOST DIESEL BULK STORAGE TANKS

Chip and paint fuel tanks.

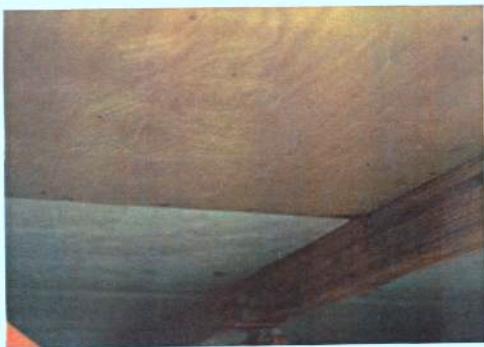
The under side of the floor panels which were rotten were replaced by securing sheets of marine ply to the wooden beams and inserting additional supports.

ROTTEN FLOOR BOARDS UNDER OLD GOUGH HOUSE WERE REPLACED WITH MARINE PLY AND THE SCAFFOLD PIPE FOUNDATION WAS PAINTED WITH NS4

The entire scaffold pipe foundation under the building was chipped and painted with NS4 paint.

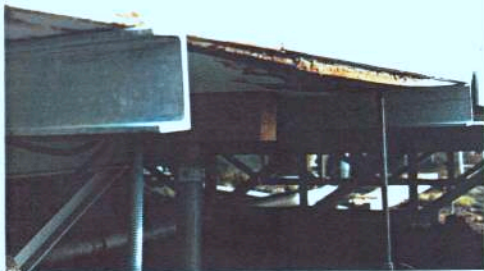
The floor of the building was pulling away from the wall panels due to the weight of the generator, but this situation has now been rectified by supporting the floor by using screw jacks, 9 x 3 timber beams and steel beams. Additional wooden beams have also been inserted under the foot pieces of the generator to spread the weight on the floor.

FLOOR OF THE HYDROGEN GENERATOR ROOM WHICH WAS IN THE PROCESS OF COLLAPSING. THIS HAS BEEN RECTIFIED WITH STEEL BRACING.

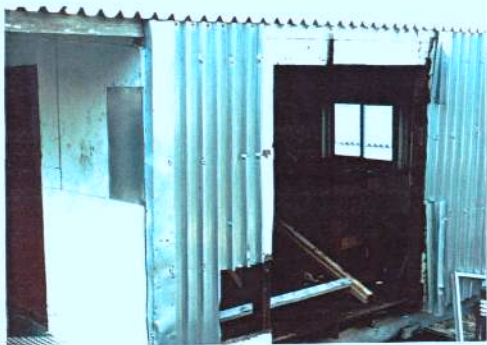
New wooden double doors were installed in the workshop area to facilitate easy removal and installation of power plants.

VIEW OF THE POWER HOUSE WHERE THE WINDOW WAS REMOVED AND NEW
WOODEN DOUBLE DOORS WERE INSTALLED

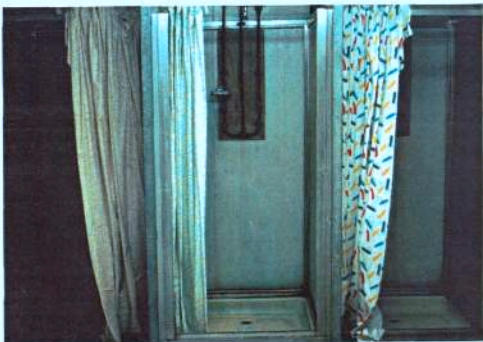
* New Marley floor tiles were fitted where the existing tiles were cracked. The cracking of the tiles was caused due to the movement of the floor panels.

NEW FLOOR TILES WERE INSTALLED WHERE THE FLOOR HAD RUSTED.
NEW ALUMINIUM SHEETING WAS INSTALLED UNDER THE TILES

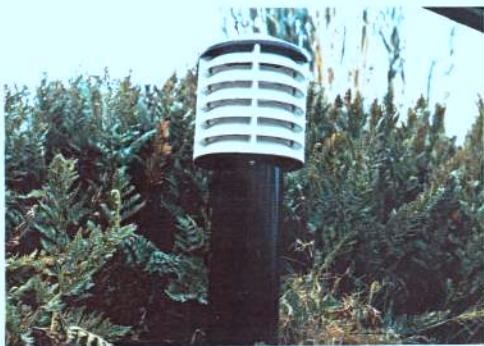
The existing Bollard light fittings between Gough House and the PWD store were replaced with new fittings.

VIEW OF THE LOW DENSITY TYPE LIGHT FITTINGS INSTALLED BESIDE THE
CAT-WALKS FROM THE HELIPAD TO THE PWD STORE

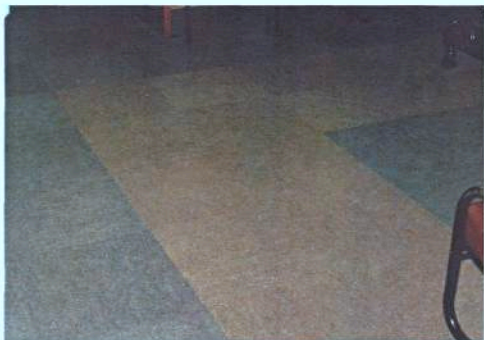
VIEW OF THE CARPETS WHICH WERE LAID IN THE TV ROOM,
PASSAGES AND BEDROOMS.
