# GOUGH ISLAND

# DEPT. PUBLIC WORKS

# 17 OCT - 13 NOV 1992

#### LEADERS REPORT

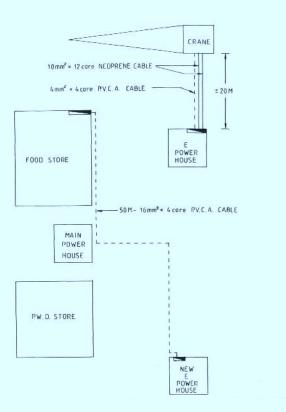
# GOUGH HOUSE DB/B M/Brd / DB/A DB/C MAIN POWER HOUSE EMERGENCY POWER HOUSE 100 KV4 100 KVA 100 KVA CRANE CONTROLE BOARD

consultant	/departmental
	DEPARTMENTAL,
liscipline	•
	ELECTRICAL
service	
	GOUGH ISLAND
SCHEMA	TC DIAGRAM OF THE
NEW CE	HANGE OVER SYSTEM
ref. no.	6508/7920/1
	6508/7920/1 J.P.Kriel

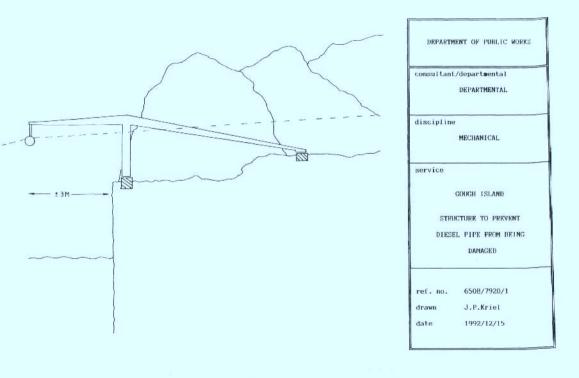
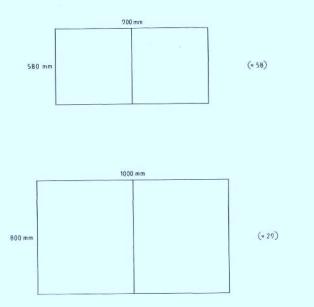
DEPARTMENT OF PUBLIC WORKS
consultant/departmental
DEPARTMENTAL.
discipline
BUILDING
service
GOUGH ISLAND
SIZES OF WINDOWS
ref. no. 6508/7920/1
drawn J.P.Kriel
date: 1992/12/15
