# Environmental Officer's report on the 52<sup>nd</sup> Gough Island relief voyage

Ross M. Wanless

*25 October 2006*

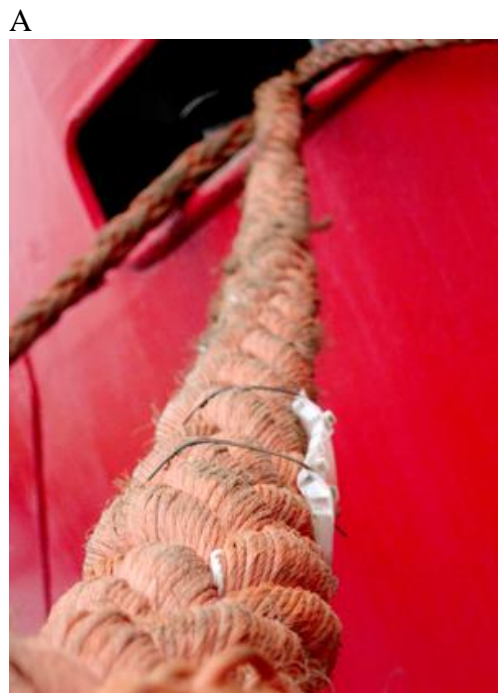
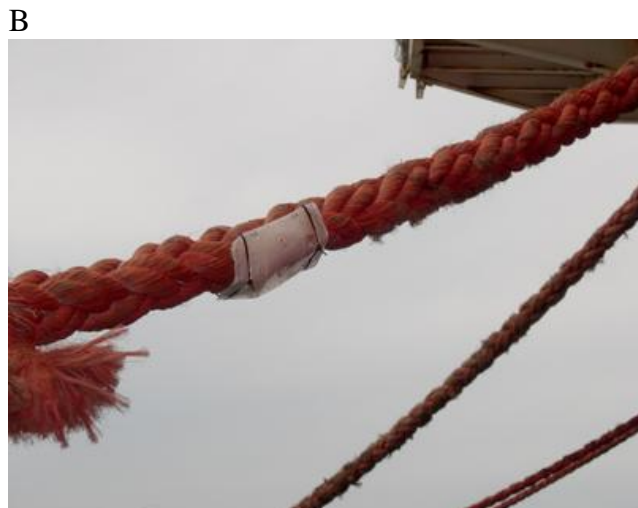
Figure 1. Glue-board inappropriately attached to a hawser, probably due to the rope twisting while under strain.

Glue boards were in place on mooring ropes, and although the old-style rope-guards were attached, they were not all properly attached and thus an unreliable back-up to the glue-boards. On 5, 6, 7 and 8 September I found some problems with the positioning of the glue-boards. When ropes come under tension they sometimes twist, causing glue boards to lie on the sides of or underneath the hawsers, thereby rendering them ineffective (Figure 1).

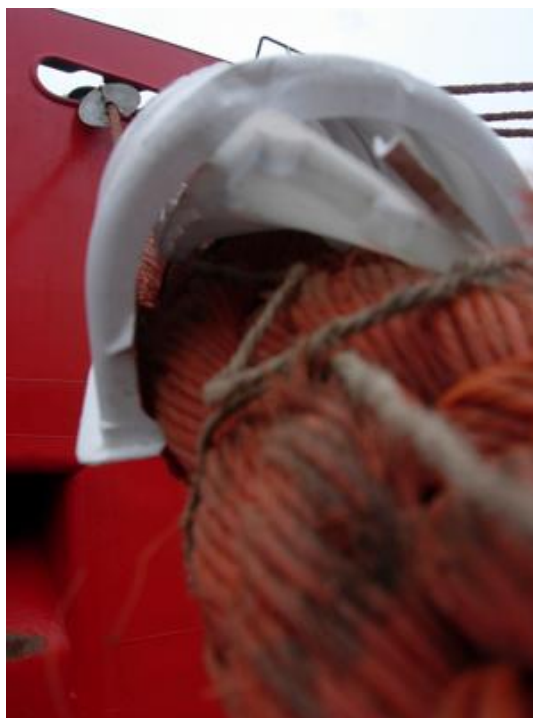
Figure 2. Glue board inappropriately attached, allowing rodents access.

A second glue board was improperly attached (Figure 2) and created a tunnel under which a rodent could move. Both issues were raised with the personnel from SWAT pest control, the appointed agents responsible for keeping the vessel rodent free.

While the use of glue boards on mooring ropes is integral to keeping rodents off the vessel, there is an unguarded gangplank, which connects the ship to the quayside 24 hours a day. This amounts to a highway for rodents to use as an access route to the ship – why would they struggle up a rope when there is a broad, stable walkway? This is a serious flaw in the rodent-guarding system and renders the use of glue boards somewhat irrelevant. This was pointed out to the SWAT pest control personnel and they undertook to investigate options to remedy the situation.

**Recommendation:** this be brought to the attention of Sam Oosthuizen and he be requested to follow-up with SWAT.

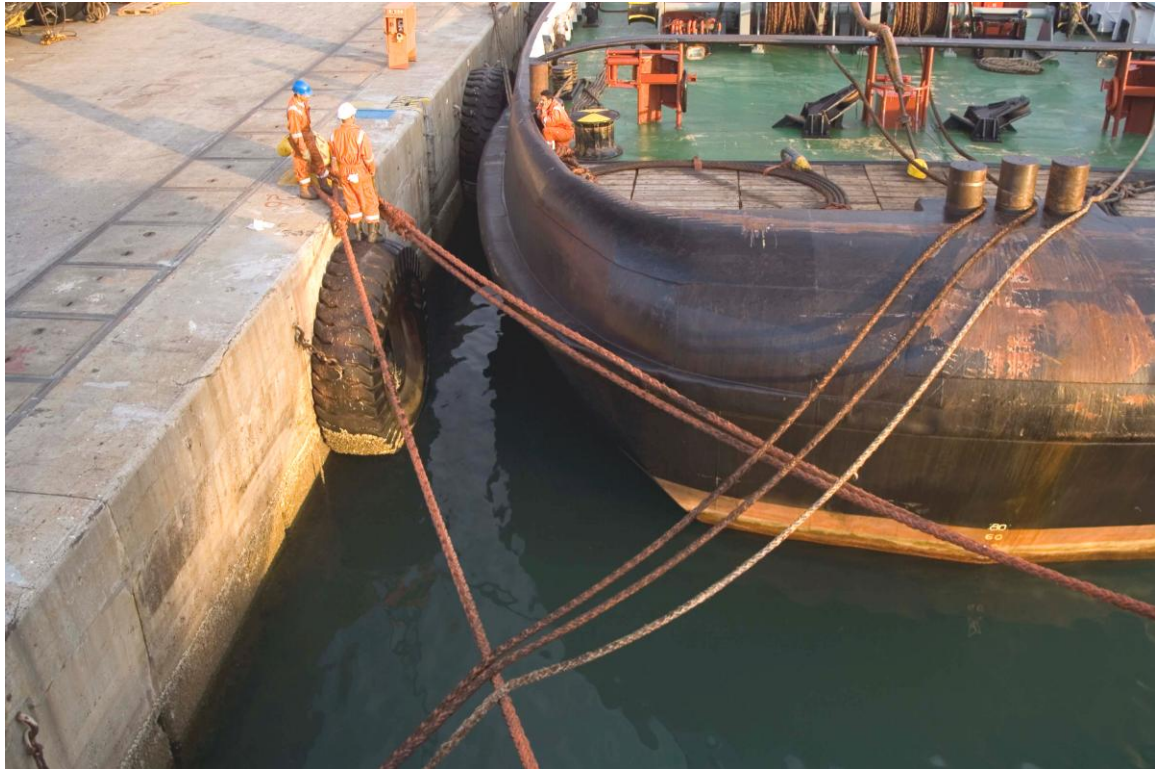
A second short-coming in rodent-proofing the SA Agulhas when alongside is the shared use of mooring bollards with other vessels. On the evening of 8 September the tugboat *Smit Amandla* was also alongside, and the hawsers for this vessel (which did not have any rodent proofing devices) were lying across those of the SA Agulhas, above the glue boards (Figure 3). This rendered the glue-boards on the SA Agulhas's hawsers useless and provided direct access for rodents to move from the Smit Amandla to the SA Agulhas.

Figure 3. Hawsers from the *Smit Amandla* lying across those from the *SA Agulhas*, above the glue boards, providing an access route for hitchhiking species.

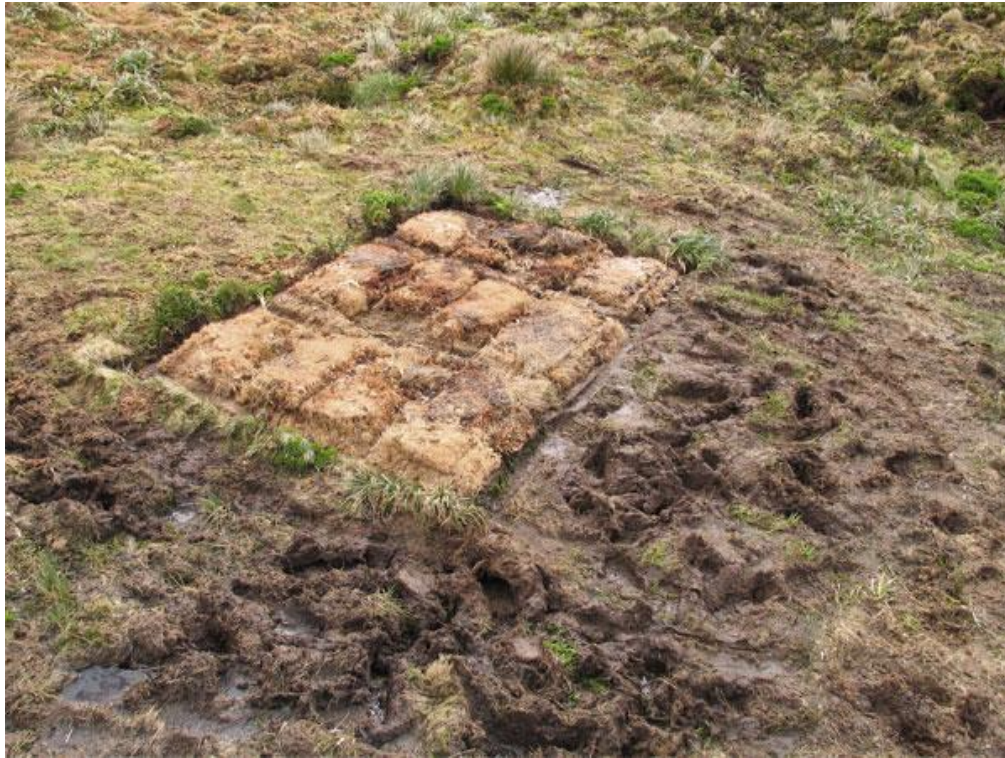
The site where a DEA&T orange cargo container was placed for the year in 2003/2004 was revisited and photographs taken. These were compared to photographs taken when the container was removed, two years earlier in September 2004 (Figures 4 and 5). The “footprint” of the container was still discernable, but the vegetation had recovered almost completely. The medium-term environmental impacts of this practice appear to be negligible.

Figure 4: Site in Gonydale after removal of a DEA&T orange container that was in use from October 2003 to September 2004

11. The use of DEA&T containers as highland depots for researchers does not appear to have any lasting negative impacts and should be continued if required.

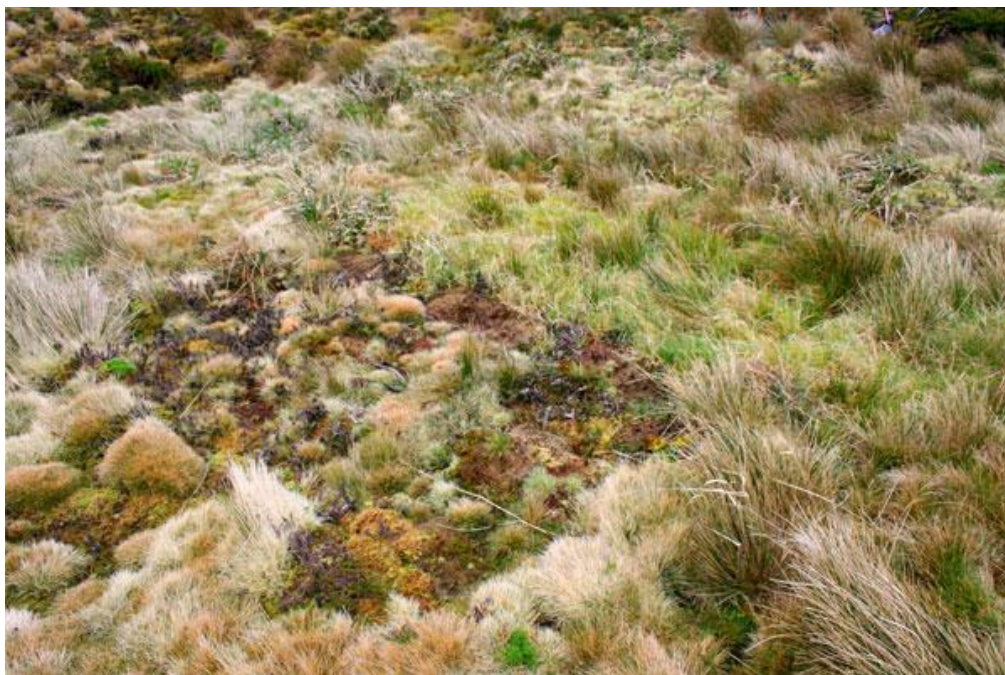
Figure 5. Same site as in Fig. 4 (from different perspective) two years later. Note the visible outline of the container site, but completely re-vegetated
