**RUNWAY ON M.I.
FEASIBILITY REPORT**

CONSTRUCTION OF A RUNWAY ON MARION ISLAND

FEASIBILITY REPORT

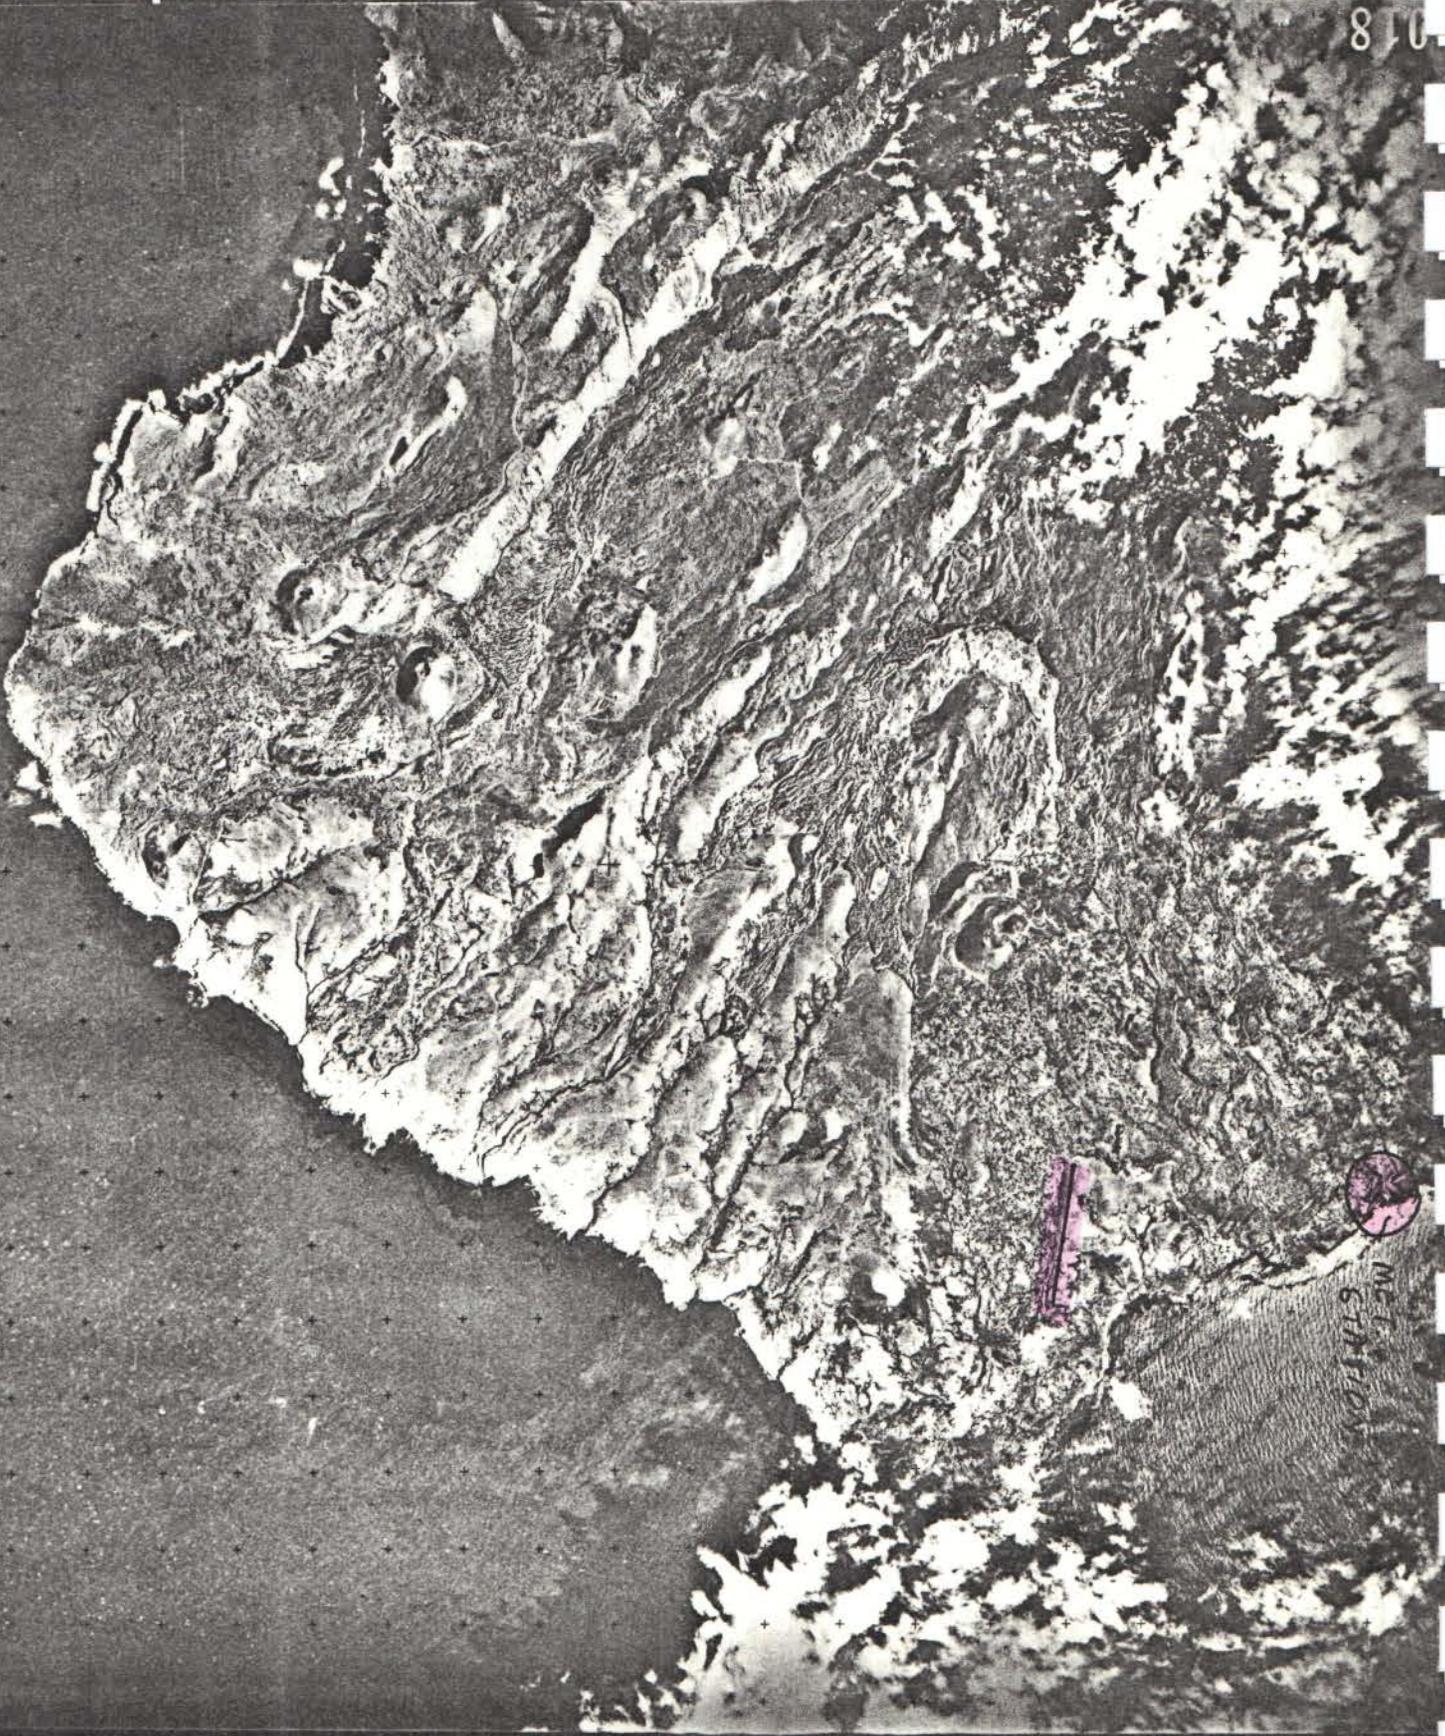
V1543B RAF 29 15APR 61 = 0927Z 6" 31300|33000 RE

The island, (Figure 1), approximately 22 x 14 km in size rises sharply from the sea (with a rough uneven precipitous coast line) to a height of 1 186 m above sea level. Apart from a fringe of grass on top of the cliffs, the foot hills have a covering of soft spongy and mossy vegetation which together with high rainfall create swampy conditions which make walking most difficult, while mechanical transport cannot be used. There are no trees and bushes of any sort on the island. The mountain peaks are mostly enshrouded in cloud and are permanently covered in snow or ice above 700 m above sea level.

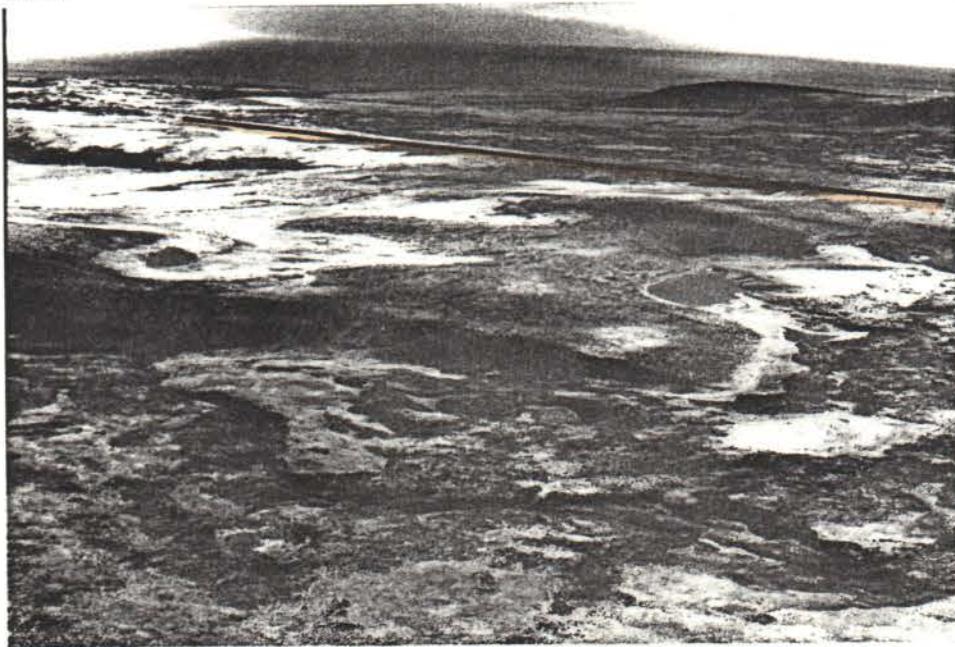
Looking East From Eastern End Of Site Towards East Cape
