RUNWAY ON M. I.
FEASIBILITY REPORT

CONSTRUCTION OF A RUNWAY ON MARION ISLAND

FEASIBILITY REPORT

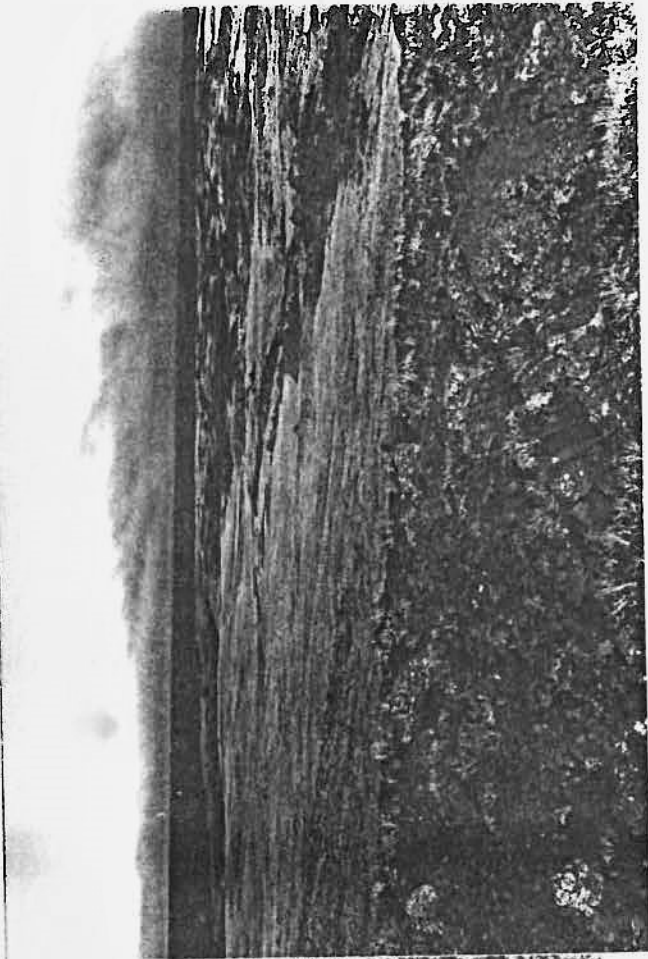
LOOKING EAST FROM EASTERN END OF SITE TOWARDS EAST CAPE
