GOUGH 86

PAINTING OF DIESEL TANKS.

COPY OF PHOTO REPORT.

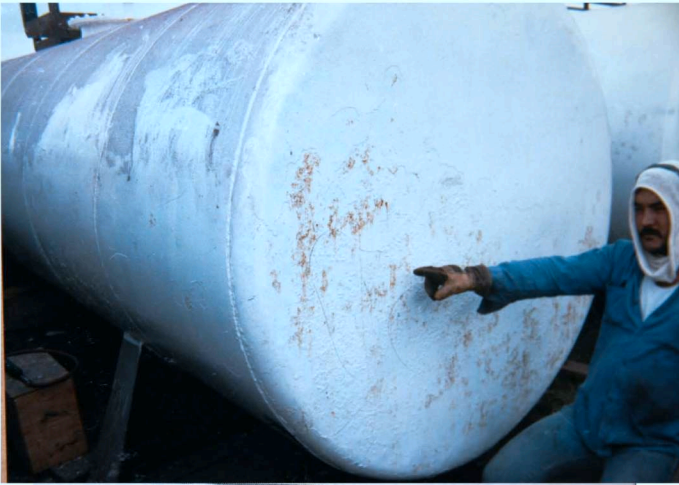
FUEL TANKS: PRIOR TO
PAINTING. NOTE LIGHTER SHADE
INDICATES WHERE TANKS WERE
TOUCHED UP IN 1985.

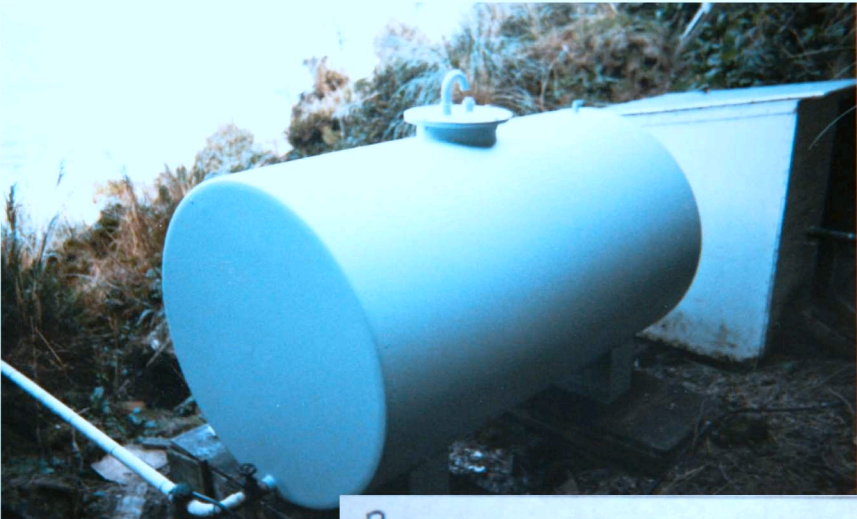
REFUELLING POINT TANK
WHICH WAS ALSO PAINTED.

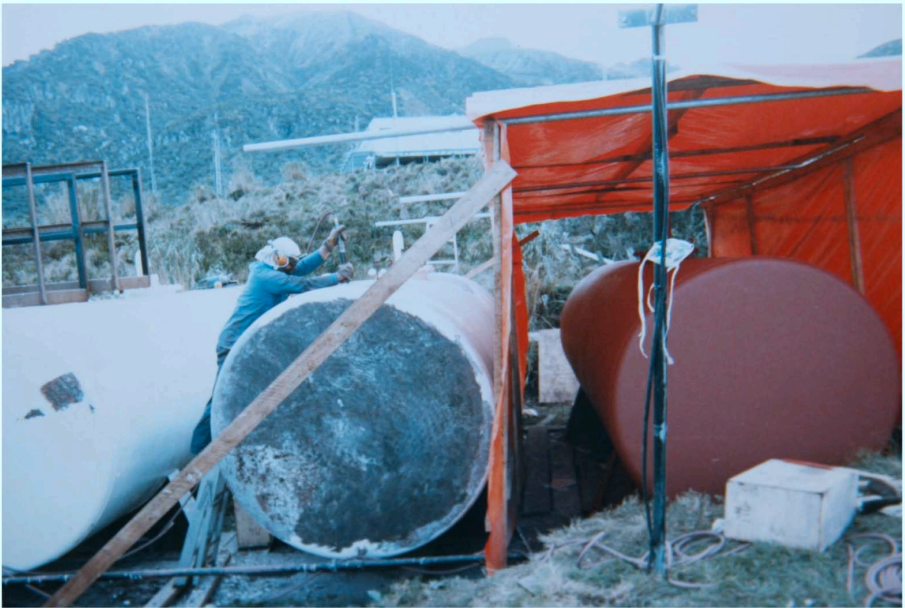
CANOPY ERRECTED FOR
PROTECTION AGAINST THE
ELEMENTS. WATER POCKETS
WERE FOUND IN BETWEEN
PAINT LAYERS AND IT IS
IMPORTANT THAT THEY ARE
KEPT DRY BEFORE PAINTING
COMMENCES.

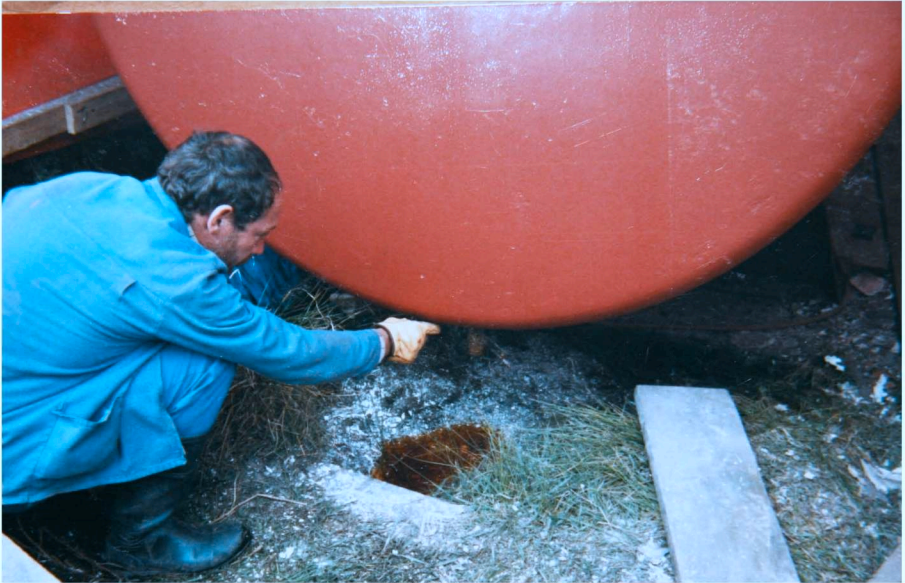
DIESEL LEAK AT DRAIN
COCK. TANKS FOR MARION
SHOULD HAVE A FRANGE.

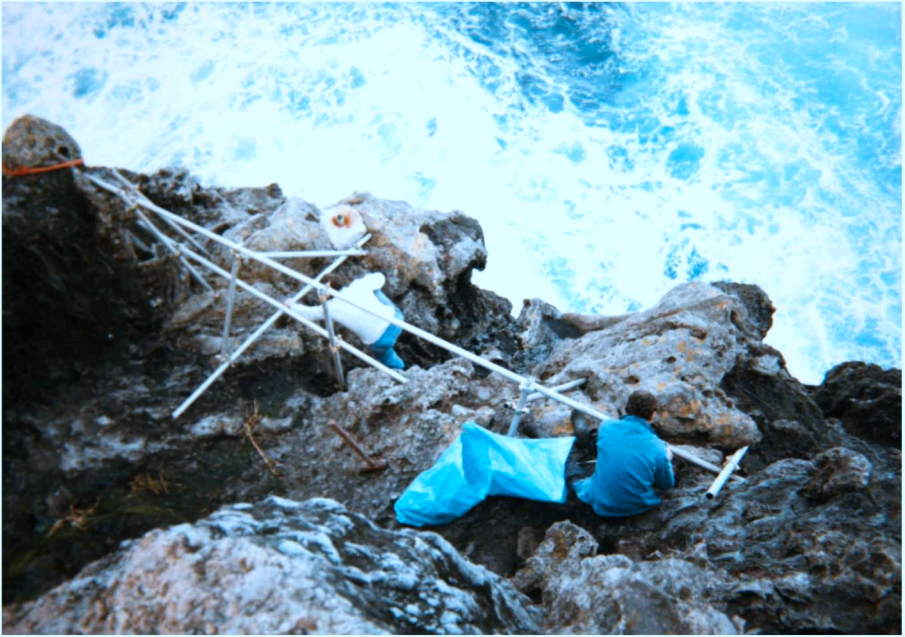
REFUELLING POINT
SAFETY RAIL

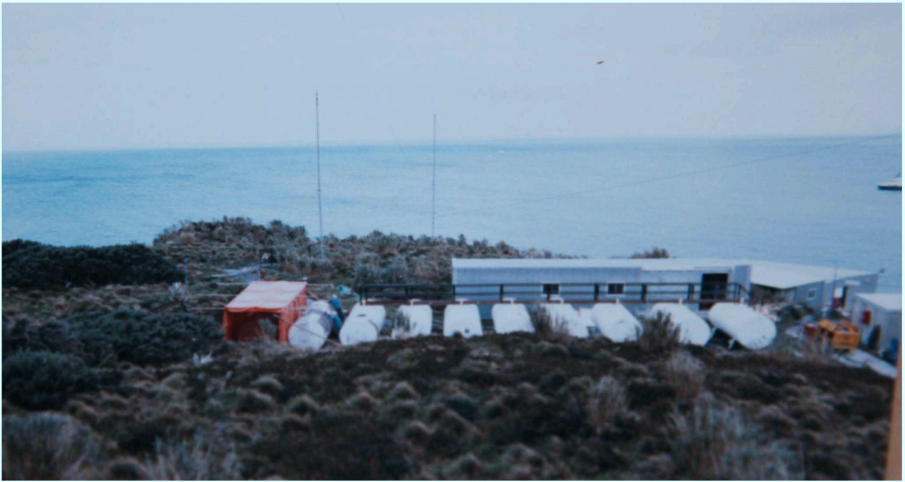
TANKS NOS 10 TO 6
HAVE BEEN PAINTED.
TANKS NO 1 TO 5
MUST BE STRIPPED
IN 1987.
